TAMU Project

**Energy Consumption Data Quality Assurance/Quality
Control Assessment Report for the
Month of November 2017**

**Utility & Energy Services
Division of Administration
Texas A&M University**

December 2017

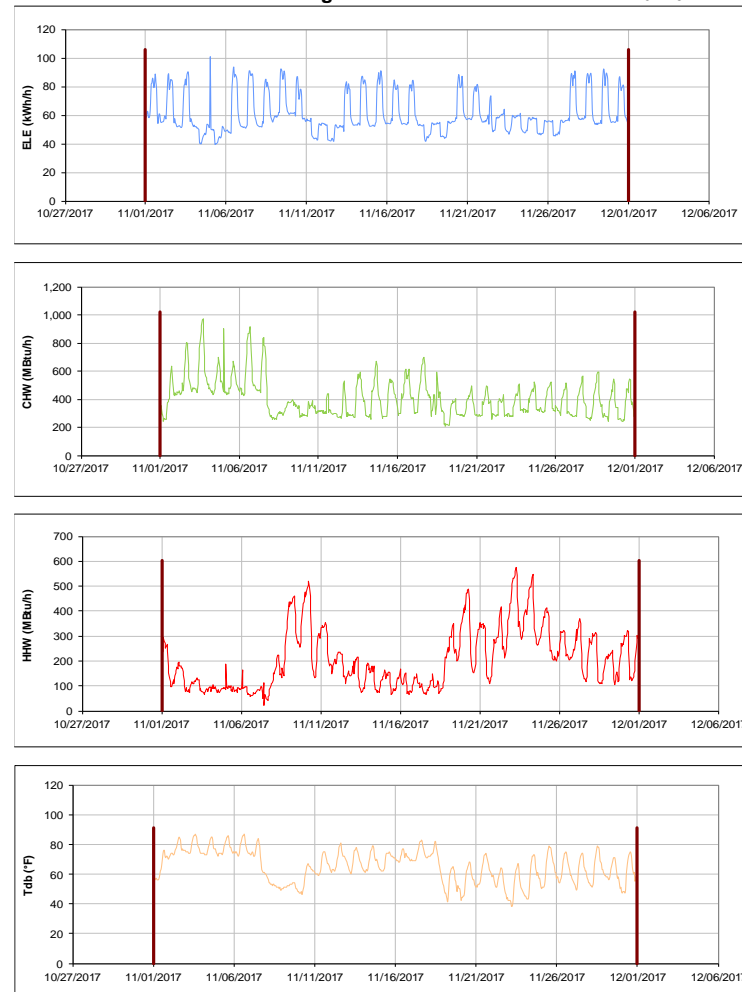
TAMU / BLDG #: 0473

Figure III-92 Hourly Whole Building Electricity, Chilled Water, and Hot Water Consumption for Williams Administration Building during the Month of November 2017 and the Corresponding Hourly Outdoor Dry Bulb Temperature for College Station, TX

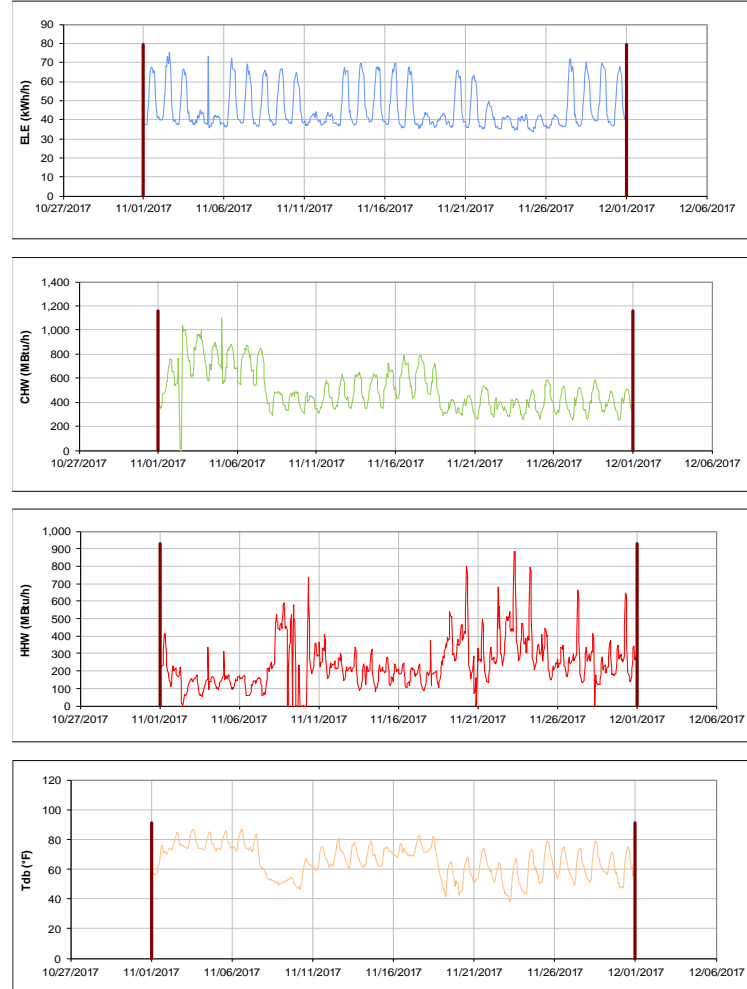
TAMU / BLDG #: 0477

Figure III-95 Hourly Whole Building Electricity, Chilled Water, and Hot Water Consumption for Anthropology Building during the Month of November 2017 and the Corresponding Hourly Outdoor Dry Bulb Temperature for College Station, TX

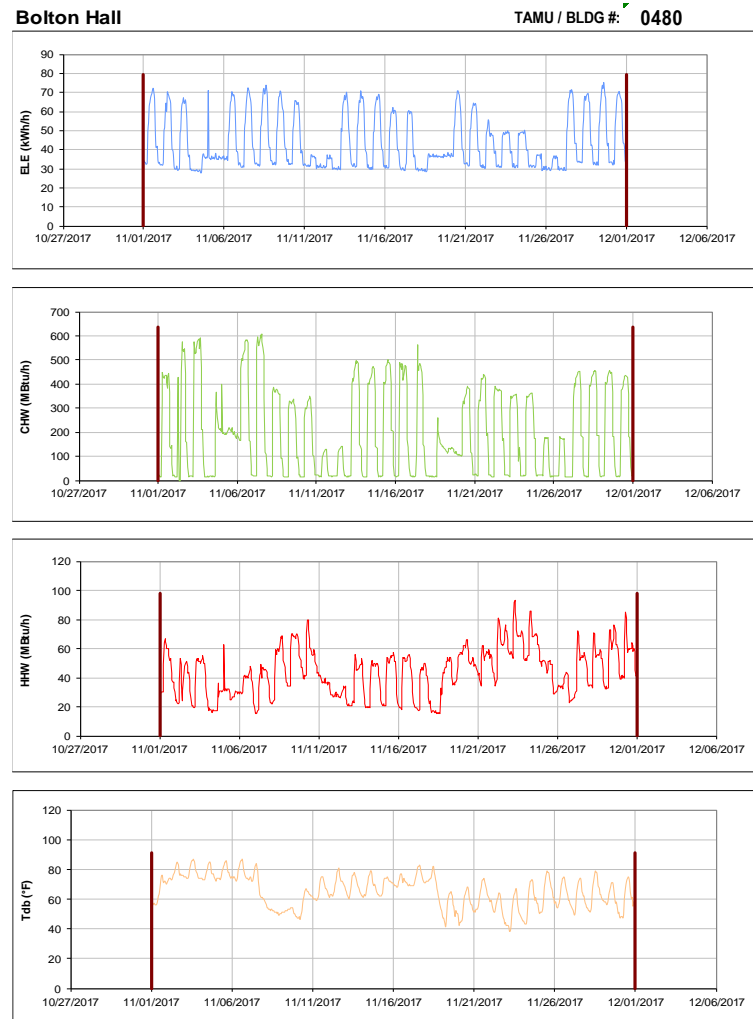
Figure III-97 Hourly Whole Building Electricity, Chilled Water, and Hot Water Consumption for Bolton Hall during the Month of November 2017 and the Corresponding Hourly Outdoor Dry Bulb Temperature for College Station, TX

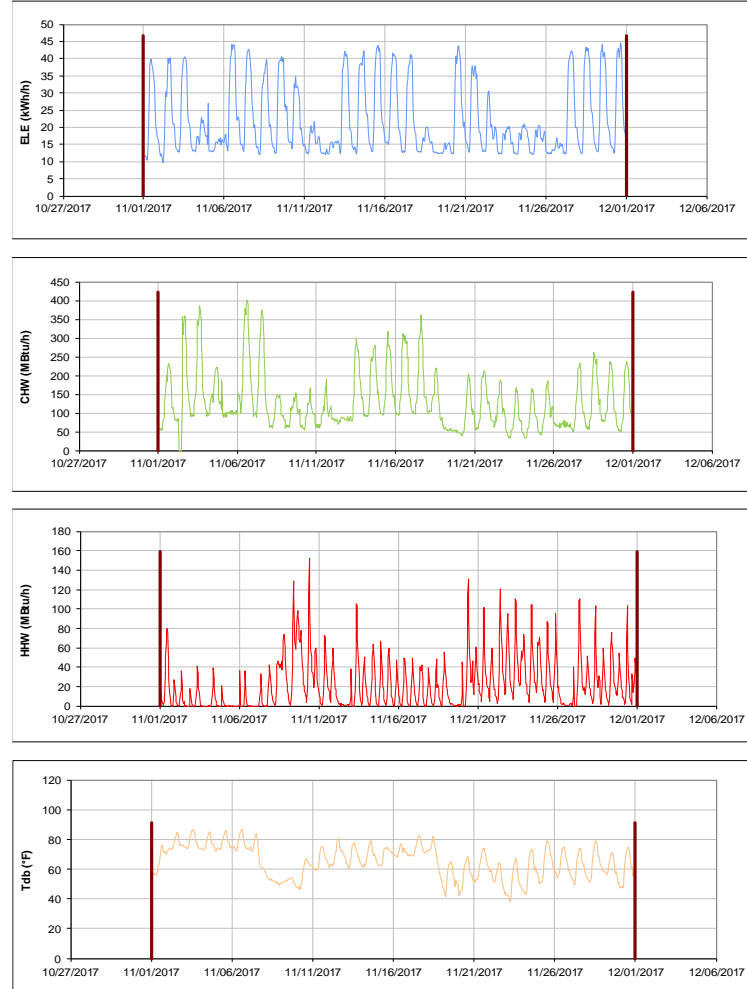
TAMU / BLDG #: 0482

Figure III-99 Hourly Whole Building Electricity, Chilled Water, and Hot Water Consumption for Fermier Hall during the Month of November 2017 and the Corresponding Hourly Outdoor Dry Bulb Temperature for College Station, TX

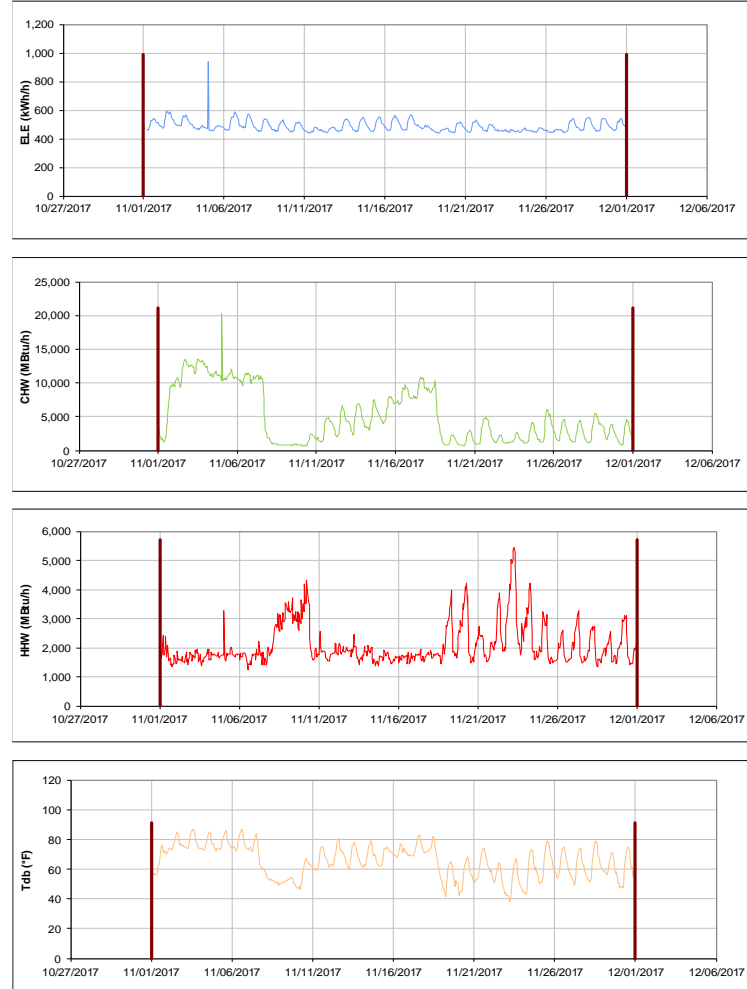
TAMU / BLDG #: 0484

Figure III-101 Hourly Whole Building Electricity, Chilled Water, and Hot Water Consumption for Chemistry Building during the Month of November 2017 and the Corresponding Hourly Outdoor Dry Bulb Temperature for College Station, TX

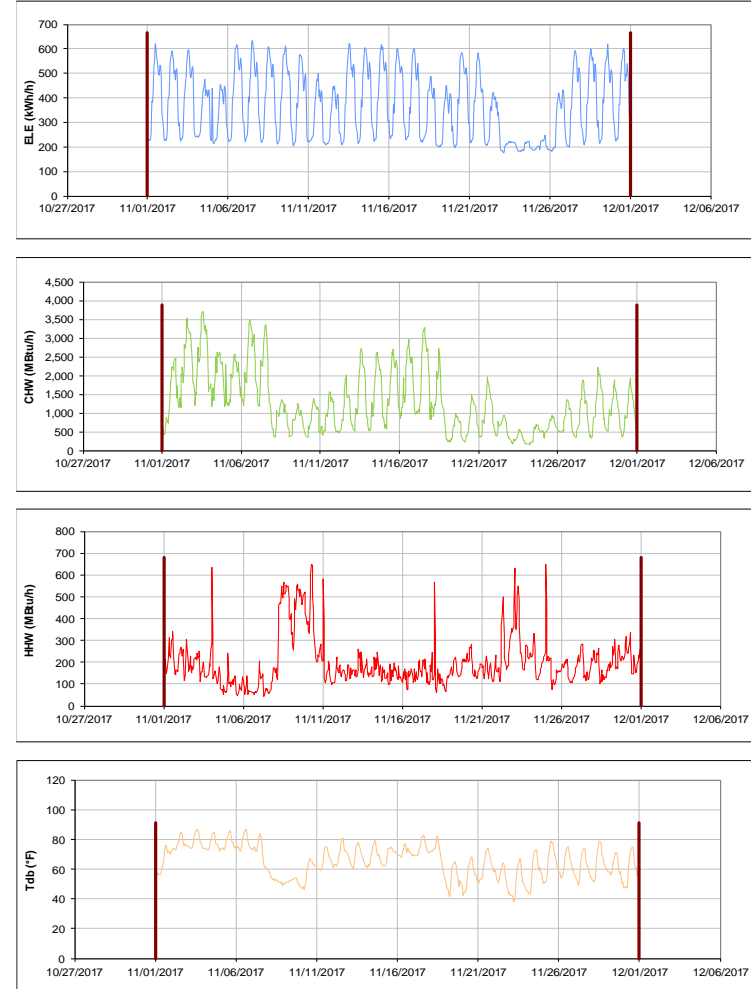
TAMU / BLDG #: 0495

Figure III-104 Hourly Whole Building Electricity, Chilled Water, and Hot Water Consumption for Sbisa Dining Hall during the Month of November 2017 and the Corresponding Hourly Outdoor Dry Bulb Temperature for College Station, TX

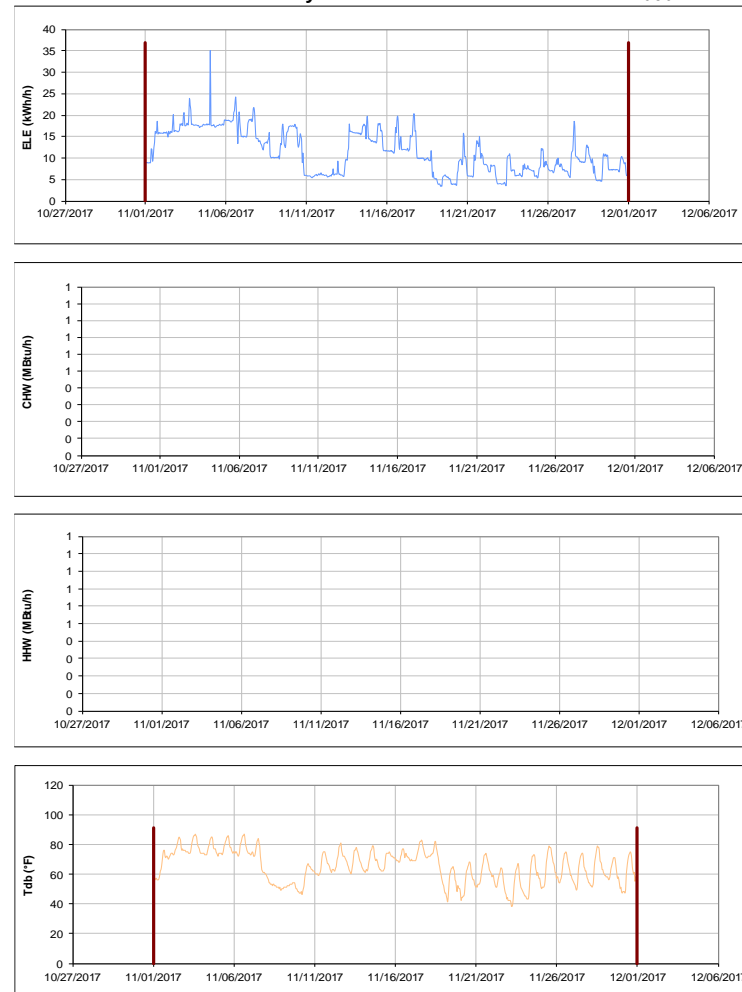
TAMU / BLDG #: 0501

Figure III-106 Hourly Whole Building Electricity, Chilled Water, and Hot Water Consumption for Concrete Materials Laboratory during the Month of November 2017 and the Corresponding Hourly Outdoor Dry Bulb Temperature for College Station, TX

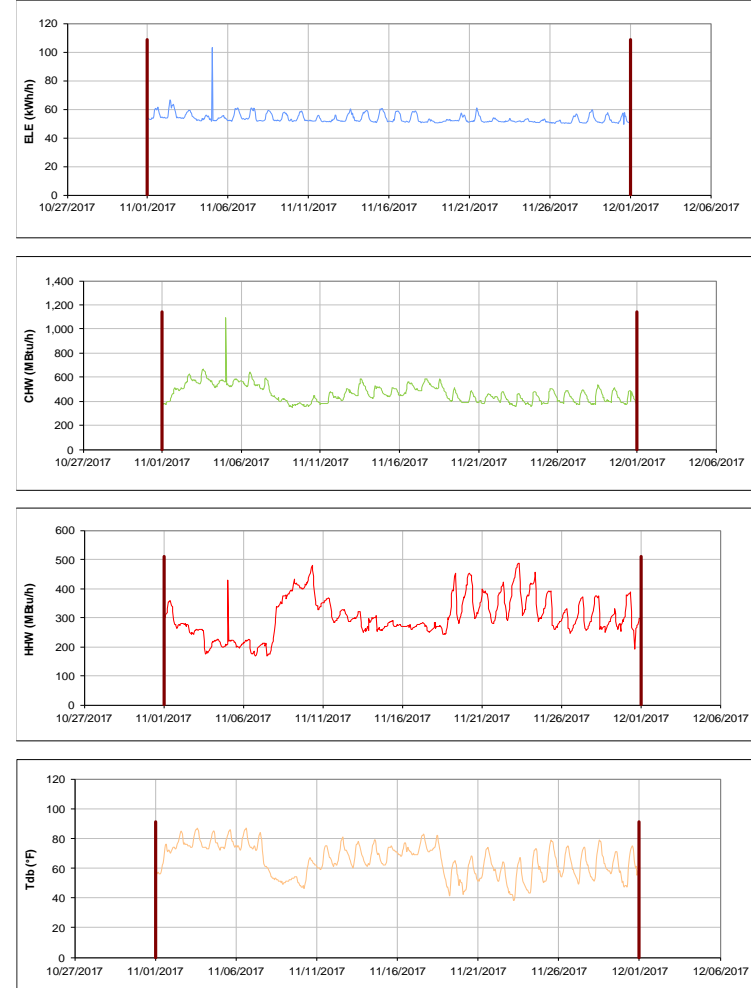
TAMU / BLDG #: 0511

Figure III-112 Hourly Whole Building Electricity, Chilled Water, and Hot Water Consumption for Heep Laboratory Building during the Month of November 2017 and the Corresponding Hourly Outdoor Dry Bulb Temperature for College Station, TX

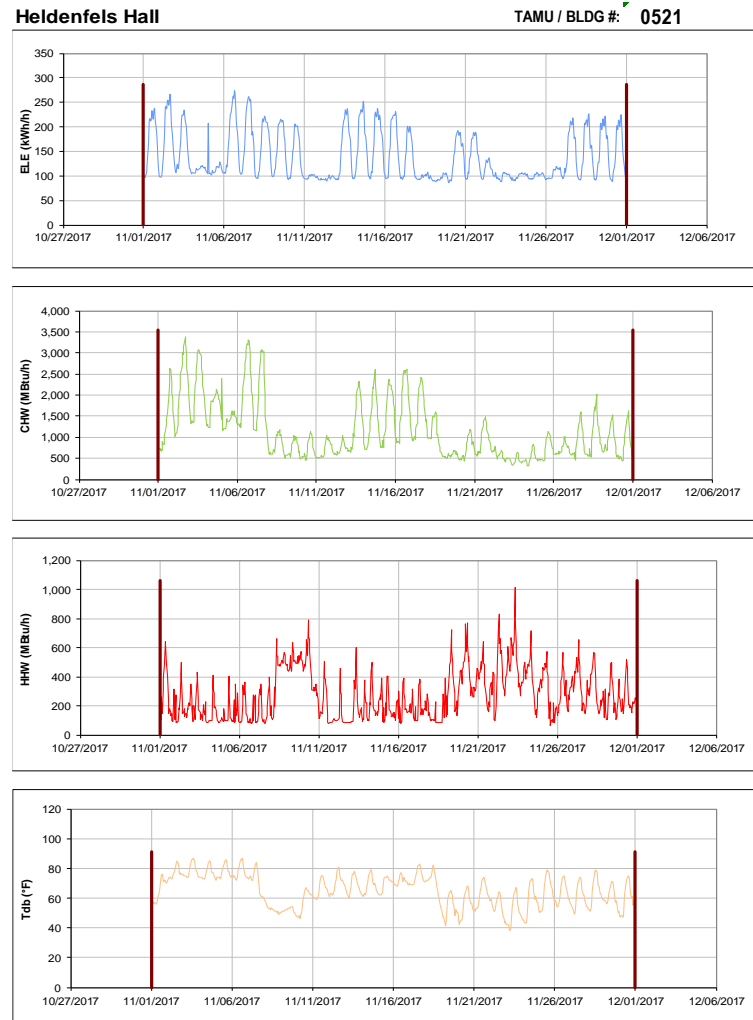
Figure III-119 Hourly Whole Building Electricity, Chilled Water, and Hot Water Consumption for Heldenfels Hall during the Month of November 2017 and the Corresponding Hourly Outdoor Dry Bulb Temperature for College Station, TX

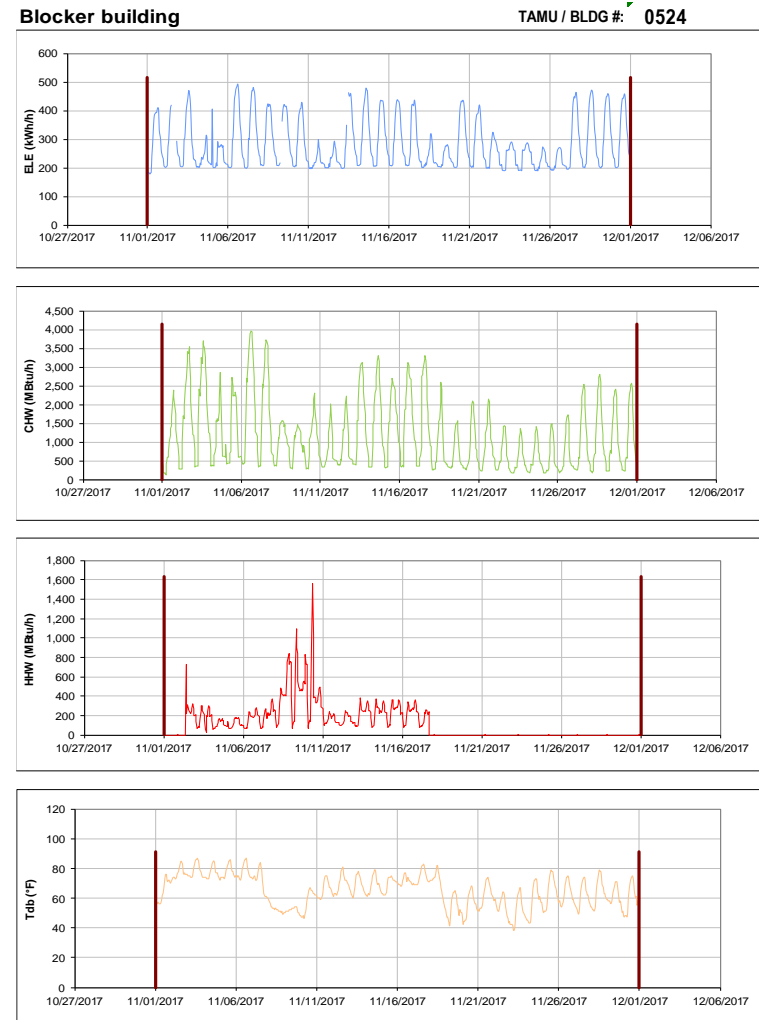
Figure III-120 Hourly Whole Building Electricity, Chilled Water, and Hot Water Consumption for Blocker building during the Month of November 2017 and the Corresponding Hourly Outdoor Dry Bulb Temperature for College Station, TX

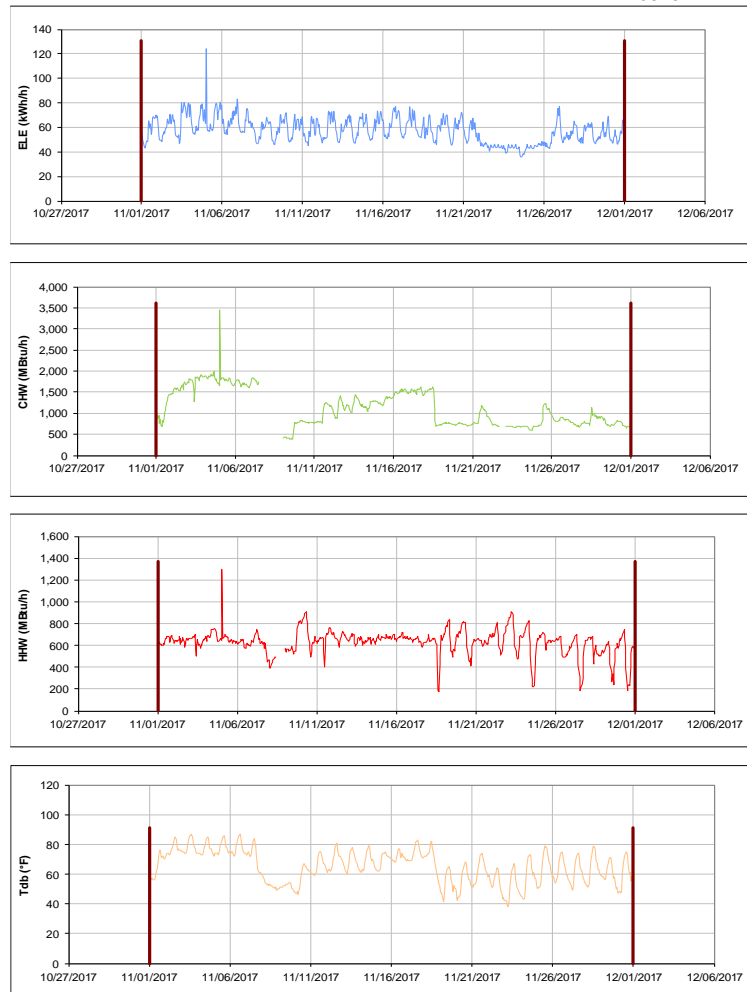
TAMU / BLDG #: 0548

Figure III-121 Hourly Whole Building Electricity, Chilled Water, and Hot Water Consumption for Clements Residence Hall during the Month of November 2017 and the Corresponding Hourly Outdoor Dry Bulb Temperature for College Station, TX

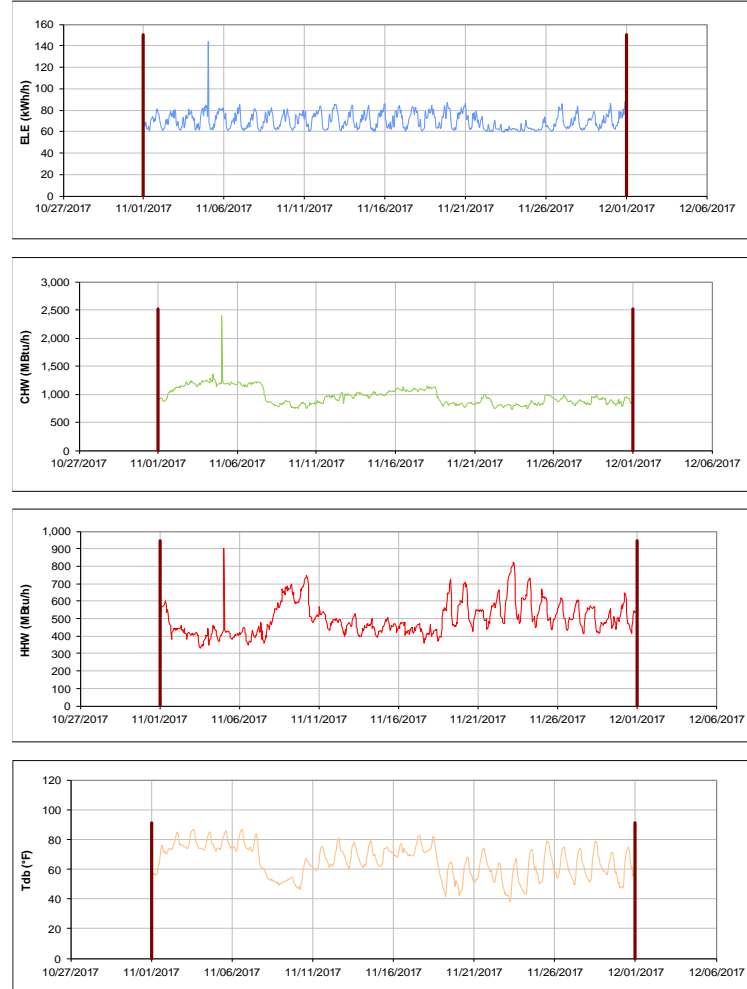
TAMU / BLDG #: 0653

Figure III-125 Hourly Whole Building Electricity, Chilled Water, and Hot Water Consumption for Hobby Residence Hall during the Month of November 2017 and the Corresponding Hourly Outdoor Dry Bulb Temperature for College Station, TX

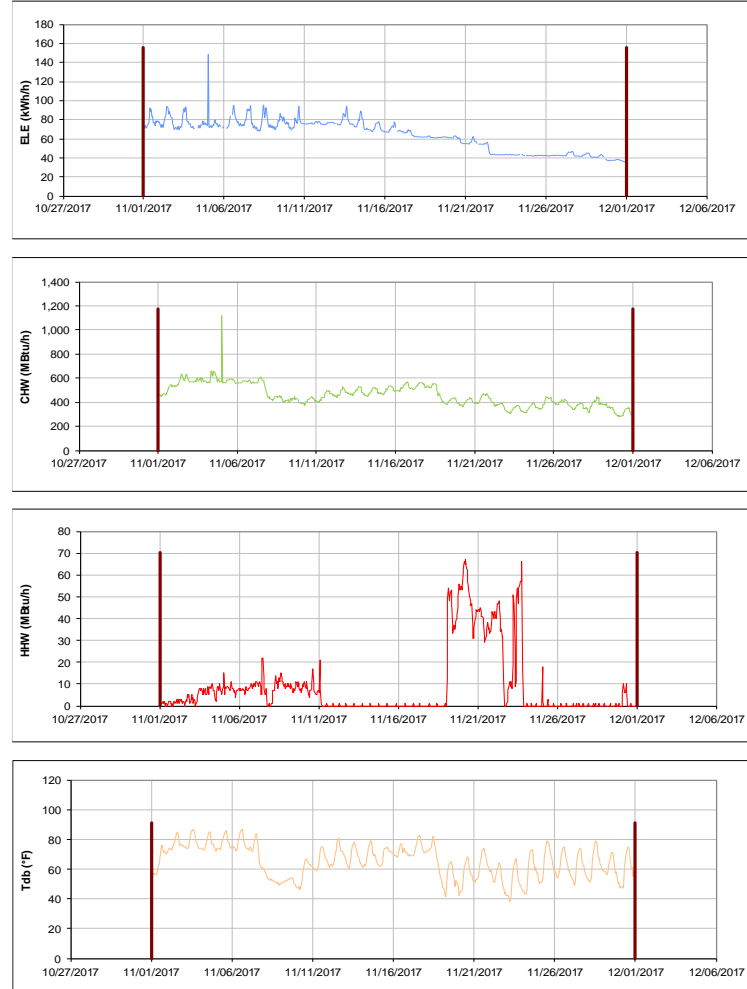
TAMU / BLDG #: 0740

Figure III-127 Hourly Whole Building Electricity, Chilled Water, and Hot Water Consumption for McNew Laboratory during the Month of November 2017 and the Corresponding Hourly Outdoor Dry Bulb Temperature for College Station, TX

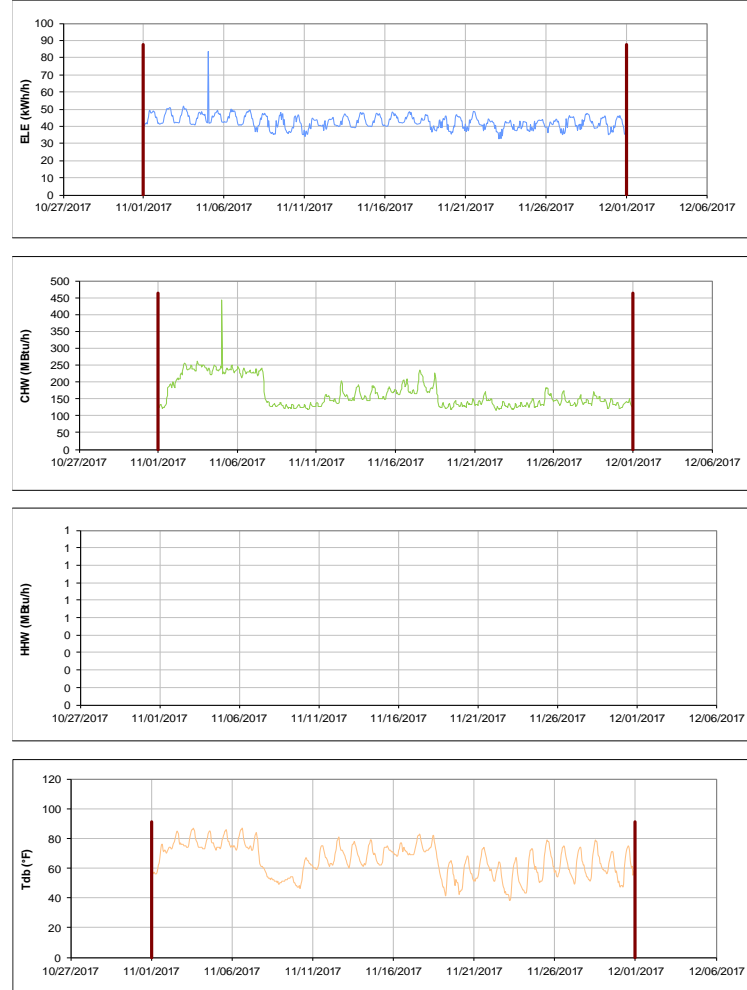
TAMU / BLDG #: 0815

Figure III-129 Hourly Whole Building Electricity, Chilled Water, and Hot Water Consumption for Entomology Research Lab during the Month of November 2017 and the Corresponding Hourly Outdoor Dry Bulb Temperature for College Station, TX

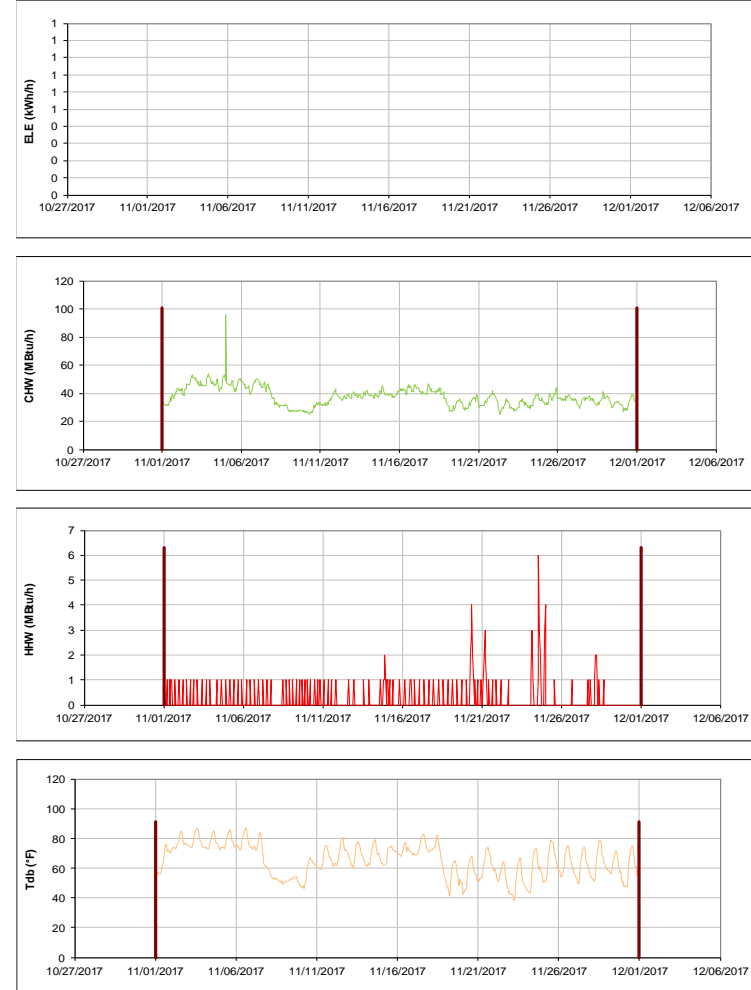
TAMU / BLDG #: 0880

Figure III-130 Hourly Whole Building Electricity, Chilled Water, and Hot Water Consumption for TVMC-Small Animal Building during the Month of November 2017 and the Corresponding Hourly Outdoor Dry Bulb Temperature for College Station, TX

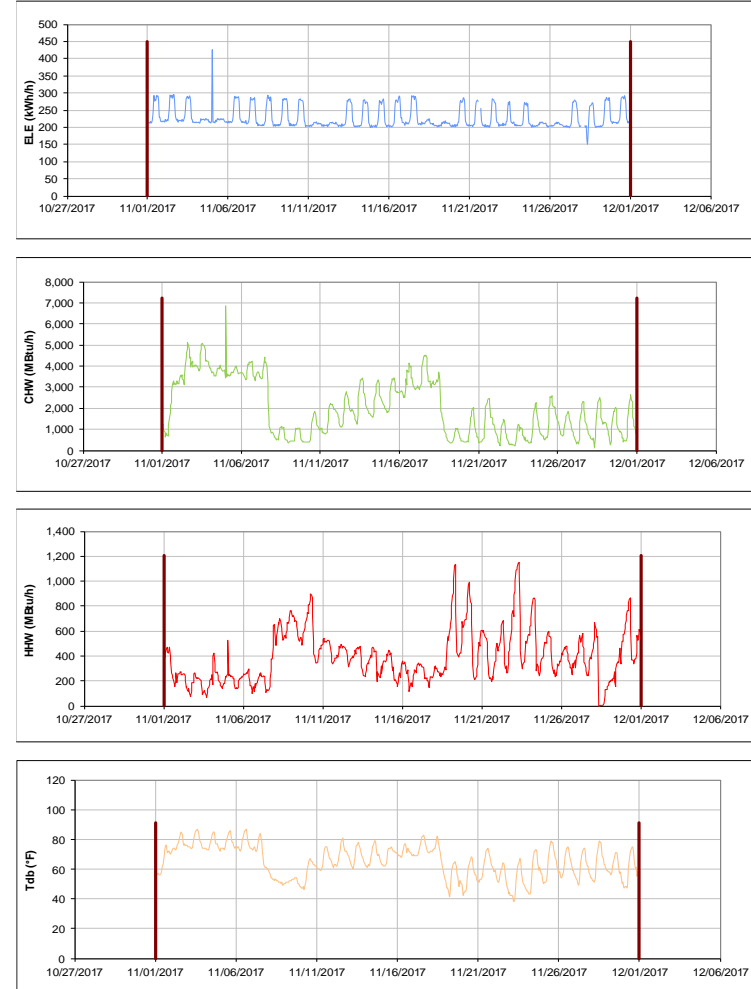
TAMU / BLDG #: 0972

Figure III-132 Hourly Whole Building Electricity, Chilled Water, and Hot Water Consumption for Laboratory Animal Care Building during the Month of November 2017 and the Corresponding Hourly Outdoor Dry Bulb Temperature for College Station, TX

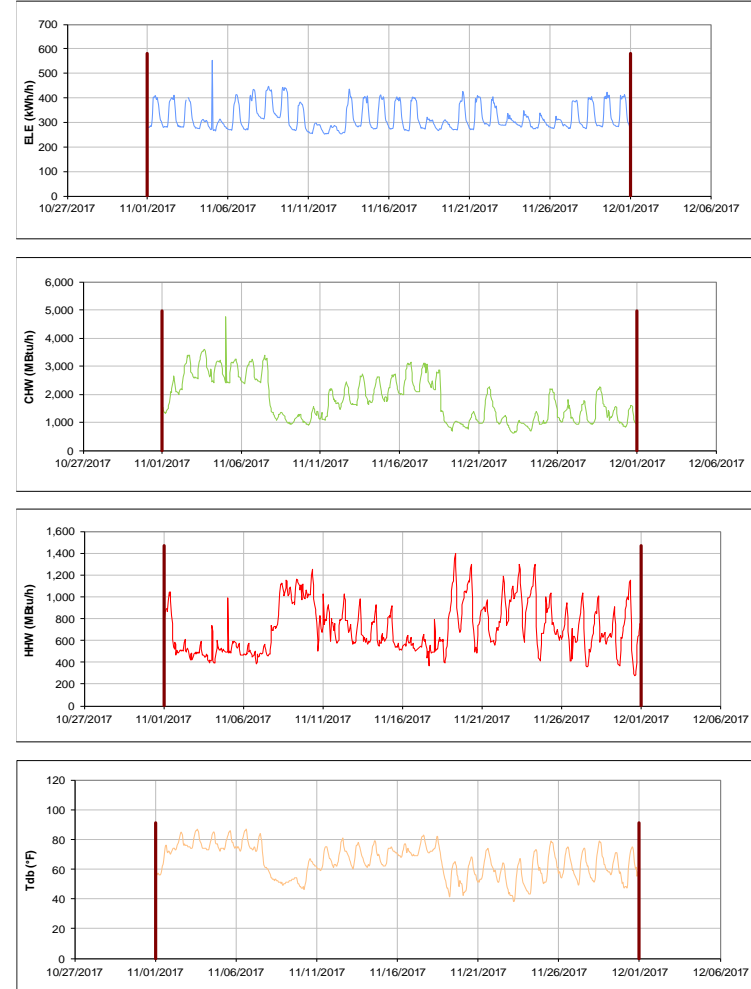
TAMU / BLDG #: 1085

Figure III-136 Hourly Whole Building Electricity, Chilled Water, and Hot Water Consumption for Veterinary Small Animal Hospital during the Month of November 2017 and the Corresponding Hourly Outdoor Dry Bulb Temperature for College Station, TX

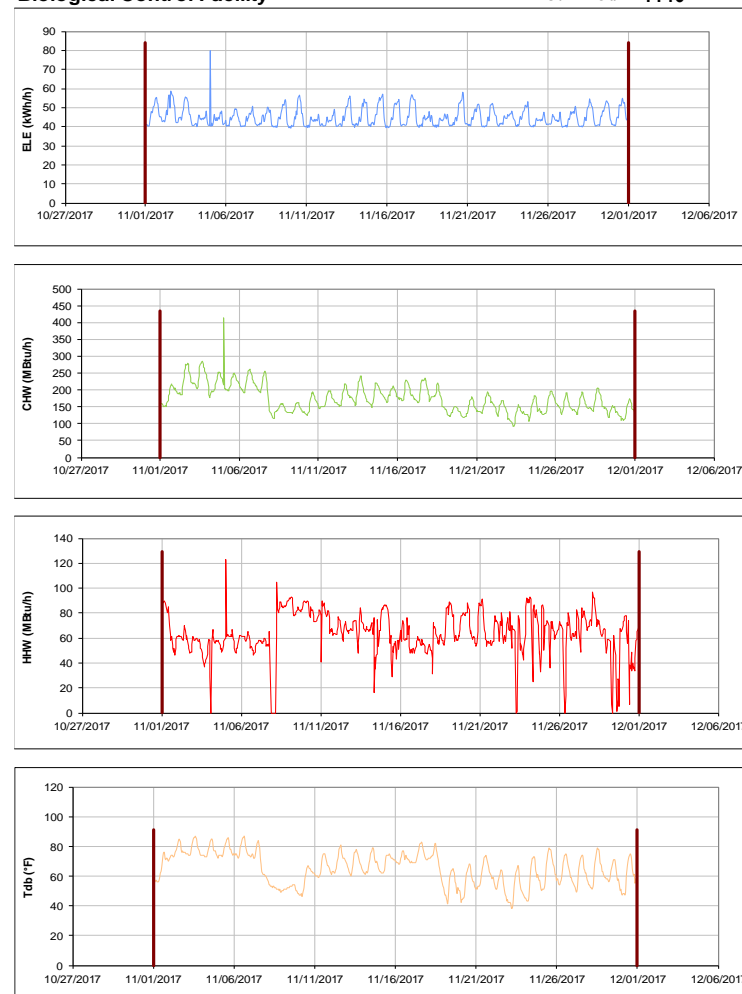
TAMU / BLDG #: 1146

Figure III-138 Hourly Whole Building Electricity, Chilled Water, and Hot Water Consumption for Biological Control Facility during the Month of November 2017 and the Corresponding Hourly Outdoor Dry Bulb Temperature for College Station, TX

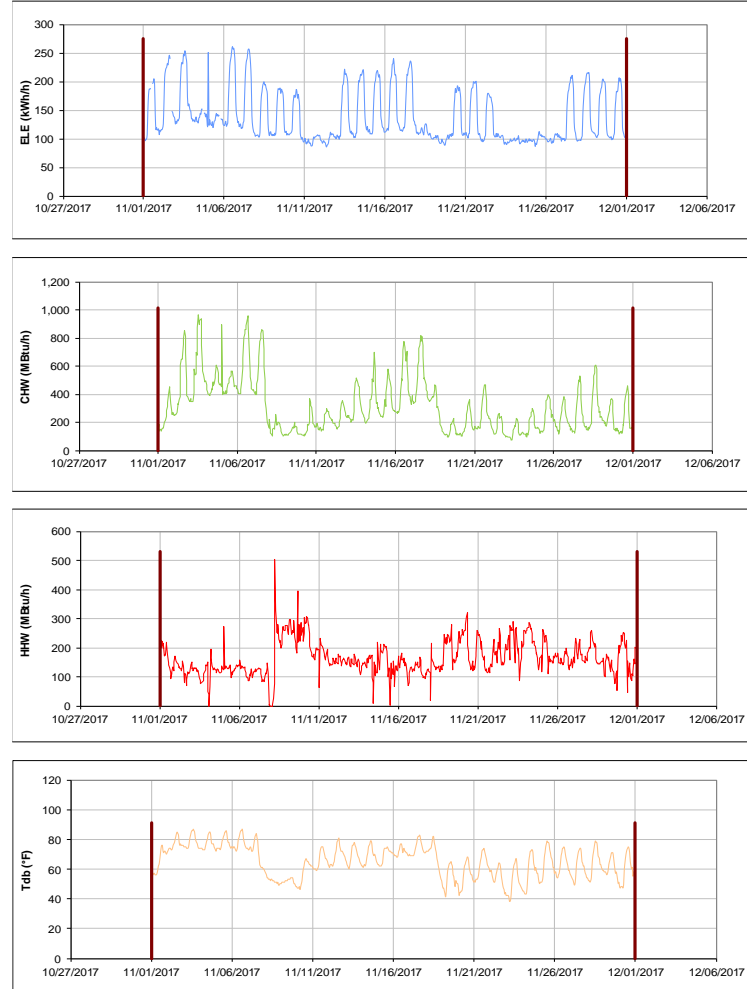
TAMU / BLDG #: 1156

Figure III-139 Hourly Whole Building Electricity, Chilled Water, and Hot Water Consumption for Physical Plant Administration & Shops during the Month of November 2017 and the Corresponding Hourly Outdoor Dry Bulb Temperature for College Station, TX

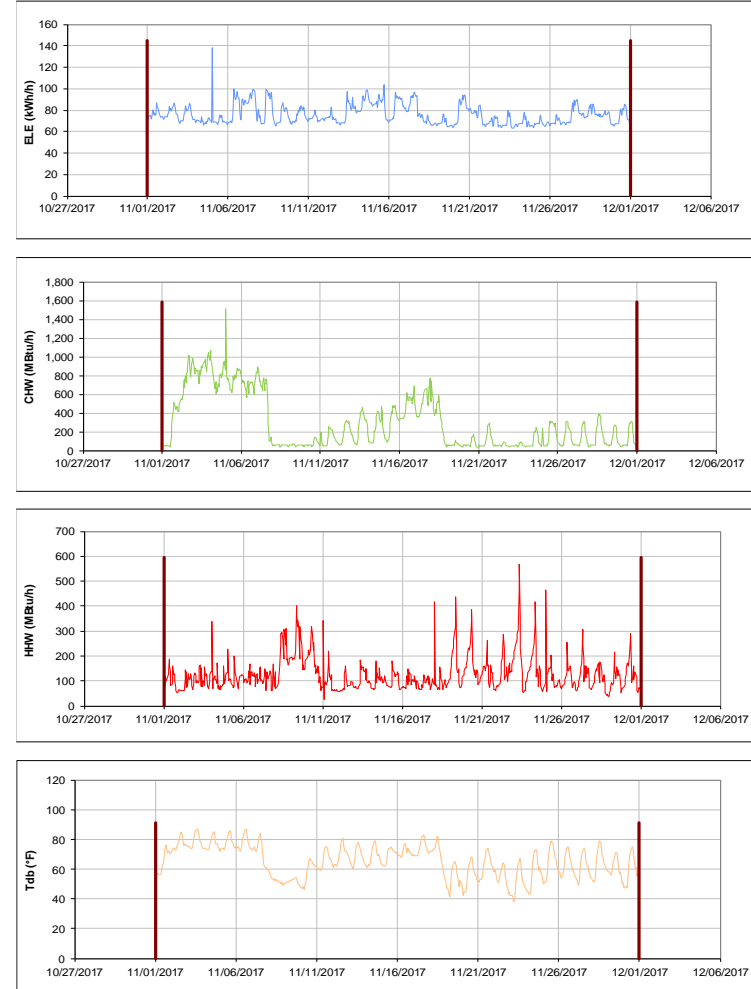
TAMU / BLDG #: 1184

Figure III-140 Hourly Whole Building Electricity, Chilled Water, and Hot Water Consumption for Veterinary Anatomic Pathology during the Month of November 2017 and the Corresponding Hourly Outdoor Dry Bulb Temperature for College Station, TX

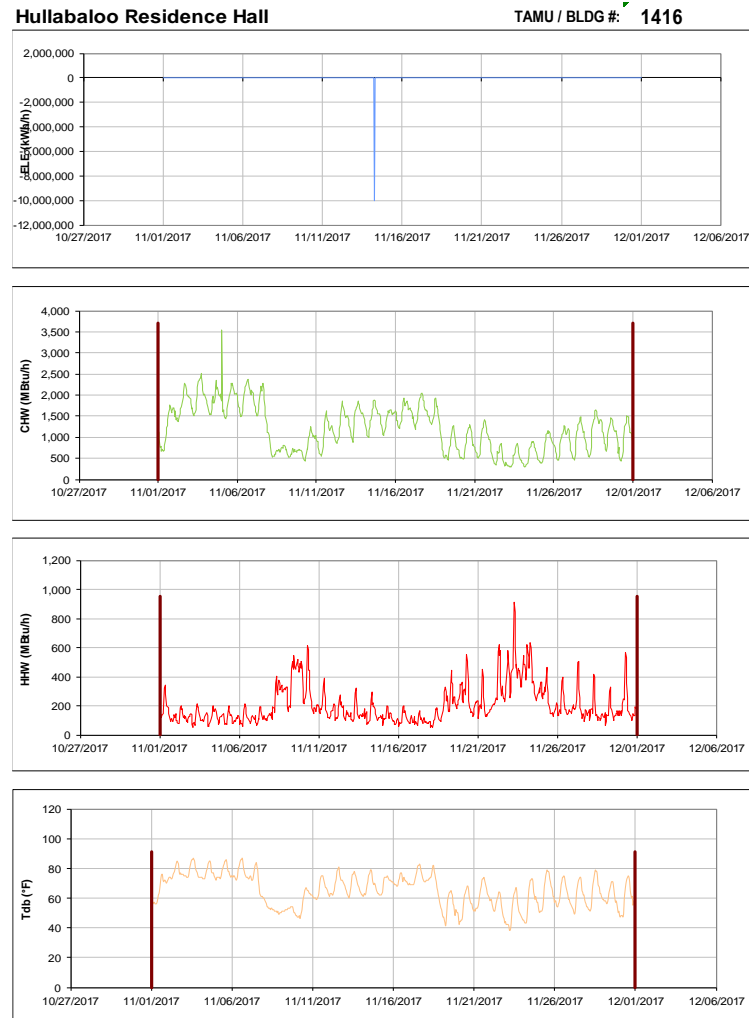
Figure III-143 Hourly Whole Building Electricity, Chilled Water, and Hot Water Consumption for Hullabaloo Residence Hall during the Month of November 2017 and the Corresponding Hourly Outdoor Dry Bulb Temperature for College Station, TX

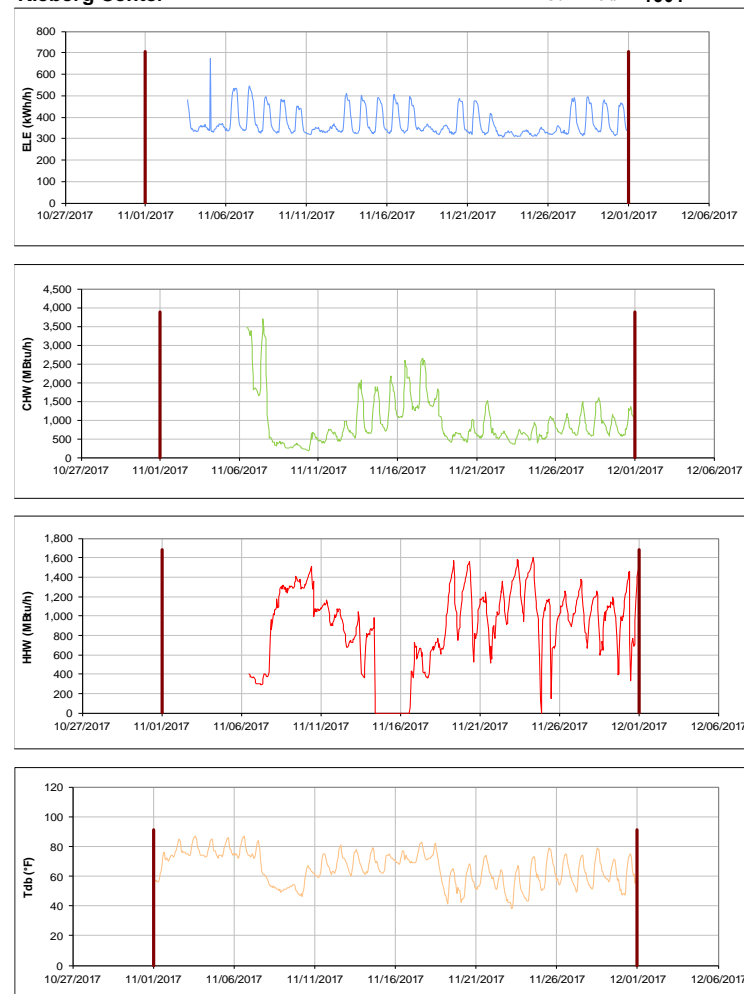
TAMU / BLDG #: 1501

Figure III-156 Hourly Whole Building Electricity, Chilled Water, and Hot Water Consumption for Kleberg Center during the Month of November 2017 and the Corresponding Hourly Outdoor Dry Bulb Temperature for College Station, TX

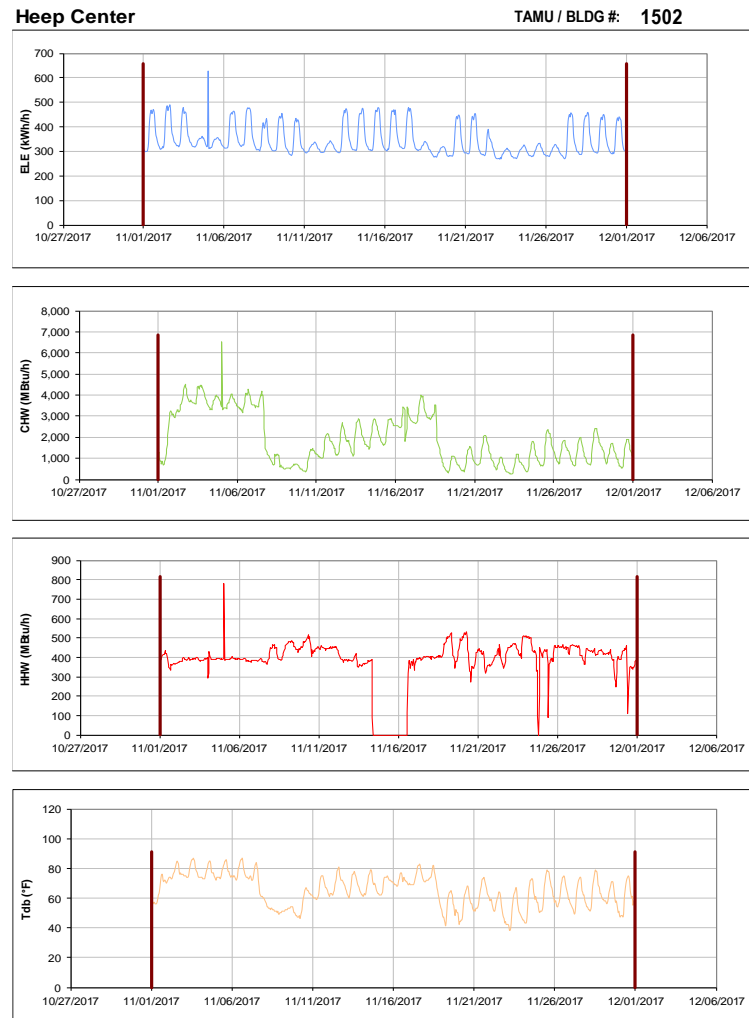
Figure III-157 Hourly Whole Building Electricity, Chilled Water, and Hot Water Consumption for Heep Center during the Month of November 2017 and the Corresponding Hourly Outdoor Dry Bulb Temperature for College Station, TX

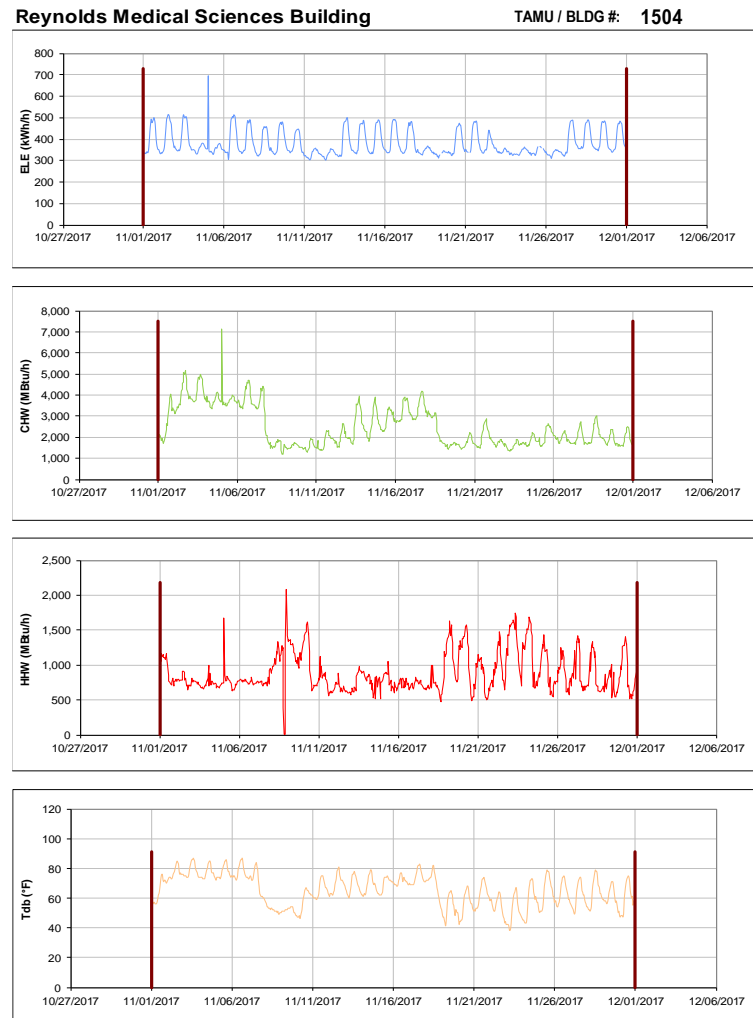
Figure III-159 Hourly Whole Building Electricity, Chilled Water, and Hot Water Consumption for Reynolds Medical Sciences Building during the Month of November 2017 and the Corresponding Hourly Outdoor Dry Bulb Temperature for College Station, TX

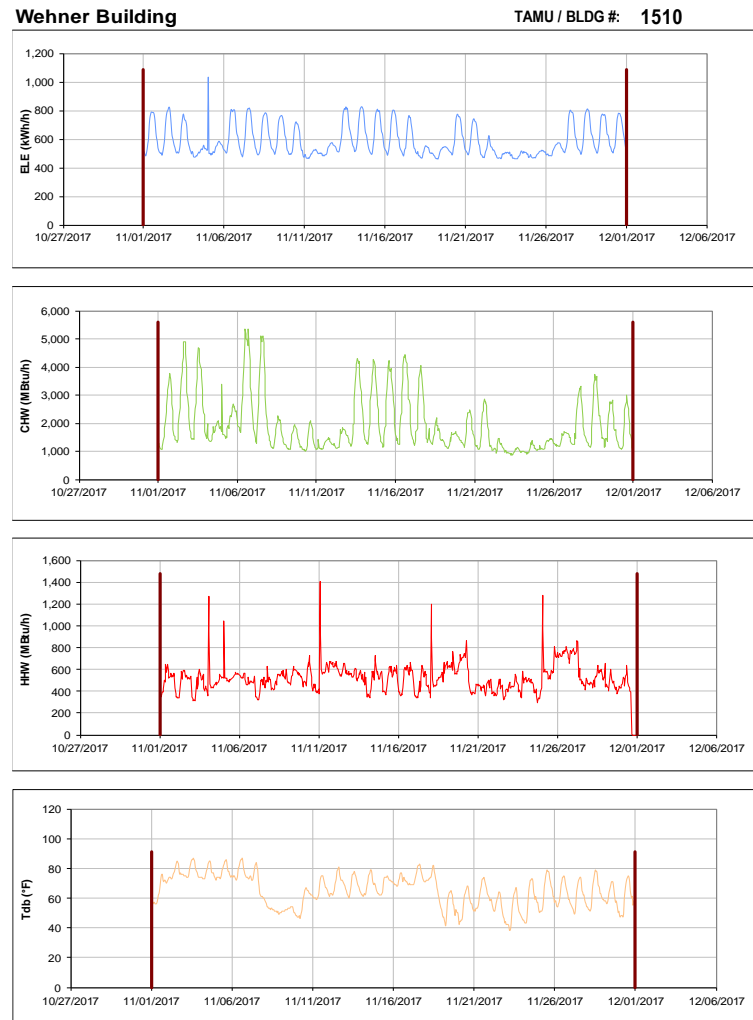
Figure III-165 Hourly Whole Building Electricity, Chilled Water, and Hot Water Consumption for Wehner Building during the Month of November 2017 and the Corresponding Hourly Outdoor Dry Bulb Temperature for College Station, TX

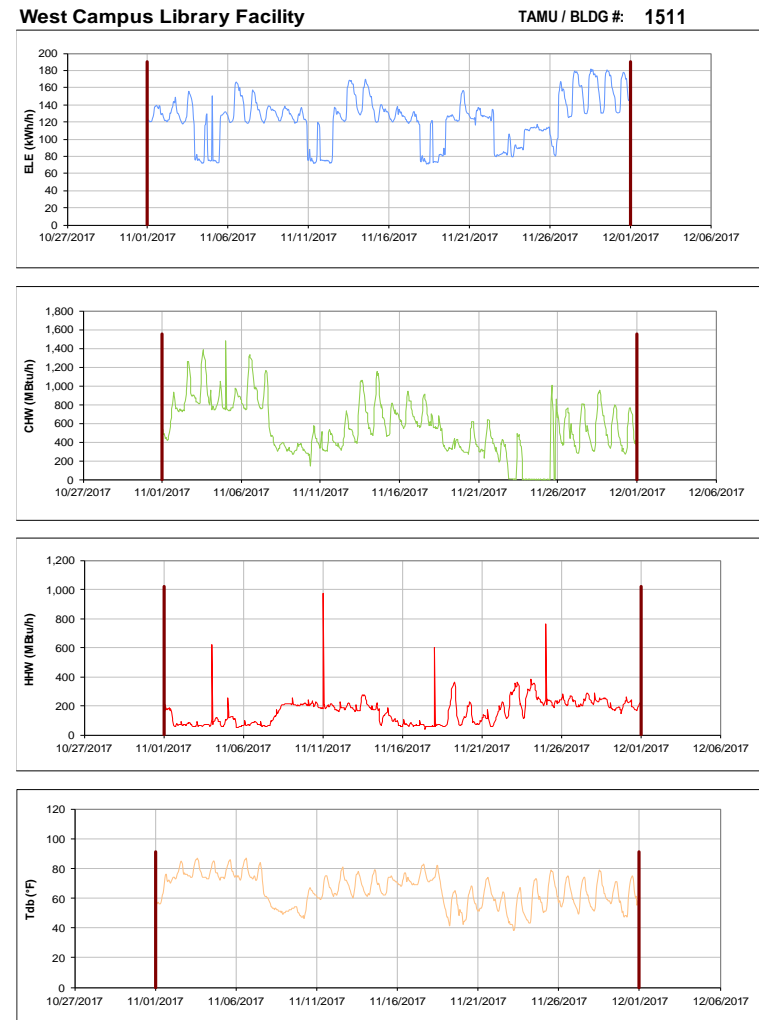
Figure III-166 Hourly Whole Building Electricity, Chilled Water, and Hot Water Consumption for West Campus Library Facility during the Month of November 2017 and the Corresponding Hourly Outdoor Dry Bulb Temperature for College Station, TX

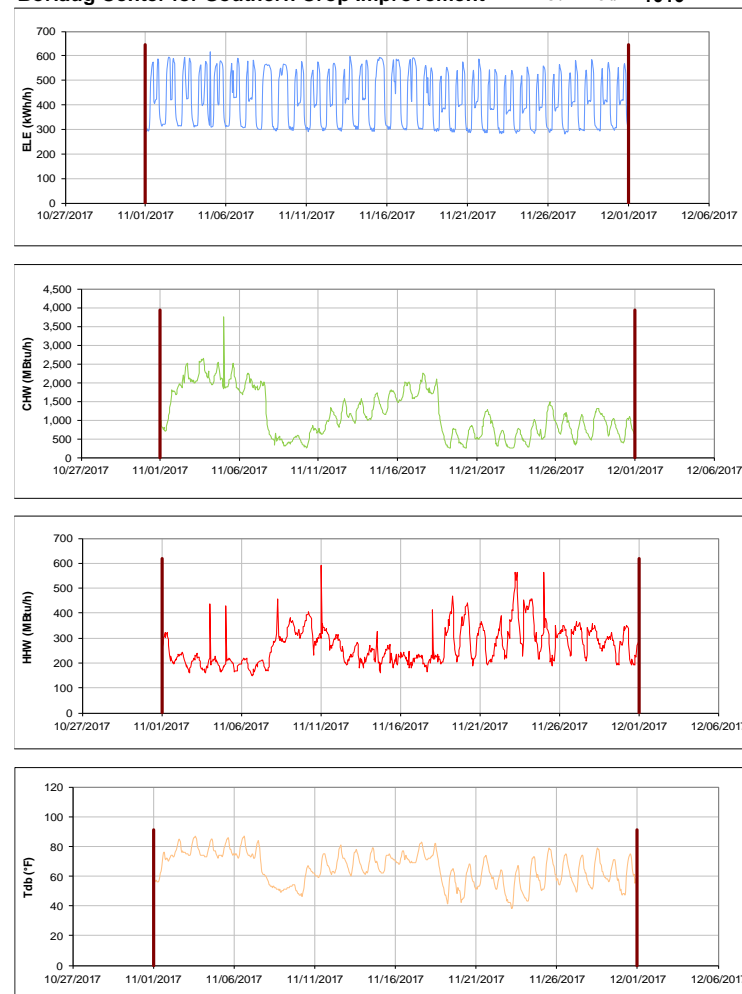
TAMU / BLDG #: 1513

Figure III-168 Hourly Whole Building Electricity, Chilled Water, and Hot Water Consumption for Borlaug Center for Southern Crop Improvement during the Month of November 2017 and the Corresponding Hourly Outdoor Dry Bulb Temperature for College Station, TX

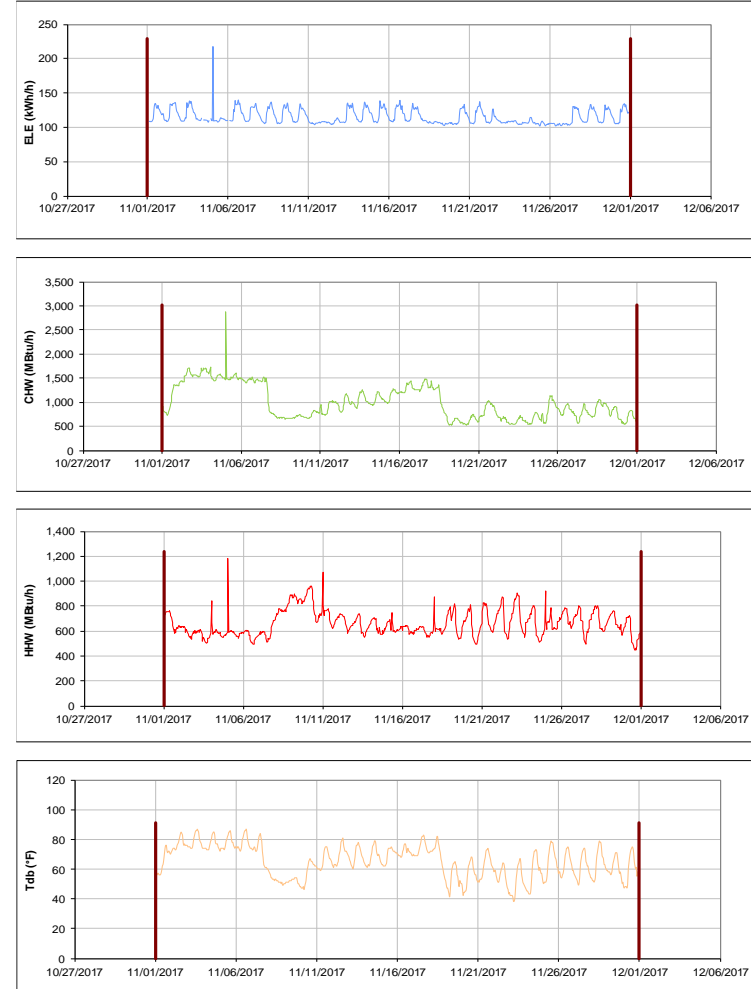
TAMU / BLDG #: 1525

Figure III-170 Hourly Whole Building Electricity, Chilled Water, and Hot Water Consumption for Nuclear Magnetic Resonance Facility during the Month of November 2017 and the Corresponding Hourly Outdoor Dry Bulb Temperature for College Station, TX
